Monumental Issues

Chicora Treats Biloxi National Cemetery Monument

Old Shiloh Cemetery is Assessed

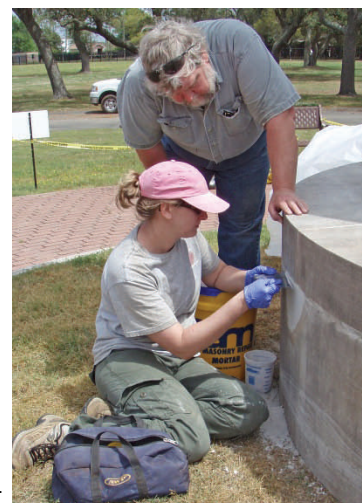
Shaping the Jahn patch.

The work was undertaken by Chicora conservators in April. Because of the height of the monument an aerial life was required. The monument was thoroughly cleaned using D/2 Biological Solution from Cathedral Stone and potable water. Afterwards, mortar joints were cleaned and repointed using NHL mortar from Virginia Lime Works. In several areas the limestone monument was patched using Jahn M-70 Mortar.

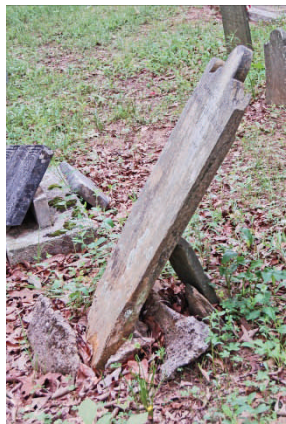
The cemetery's stones are beautiful, but many are broken and some — like this example — are certain to suffer additional damage if not properly repaired.

We found significant damage to a broad range of the stones in the cemetery. Many of these stones also exhibited inappro-

prate repairs that had been made over the past 30 years in an effort to maintain the burial grounds. A number of stones were found out of the ground — these "orphan stones" should be reset to prevent their loss or damage by mowing.

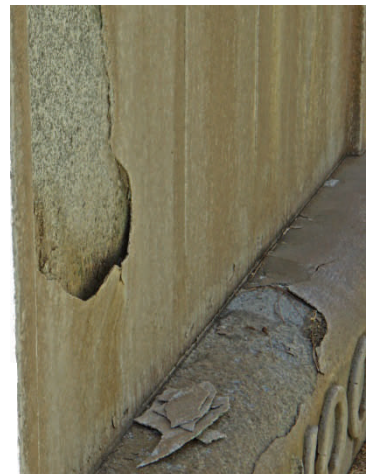
— and in — stones as a result of irrigation. The results range from disfiguring monuments to the actual spalling of stone — even granite.

Here the deposits are causing spalling of a granite monument.

Solutions include curtailing irrigation, using flood irrigation, seeking new sources, or eliminating irrigation entirely.

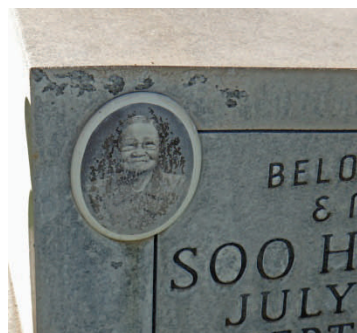
Dissolved minerals are coating this stone, obscuring the porcelain photograph.
